Transport
Canada

TP 6980E

Issue 2/2003

Canadian Aviation Service Difficulty Reports

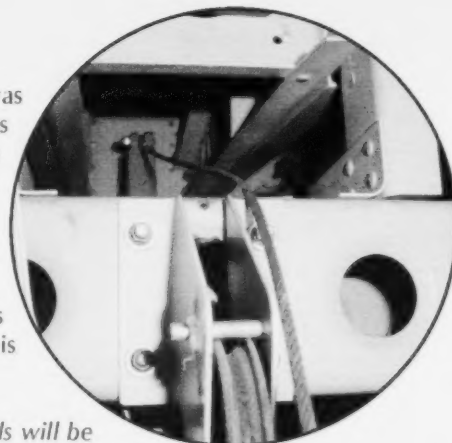
The elevator bell crank of this aircraft was replaced. This task was completed and signed by two qualified mechanics. The aircraft was returned to service and flew 84 hours with the elevator control cable incorrectly installed as indicated on the picture.

Complacency? Fatigue? Human factors certainly had a role in this incident. Mistakes can occur, however some may be avoidable. This incident could have had serious consequences.

Table to CAR 571.10 states - *Work that disturbs engine or flight controls will be inspected for correct assembly, locking and sense of operation, by a least two persons, and the technical record contains the signatures of both persons.*

CAR 571.11(6) - *If a maintenance release is signed by a person in respect of work performed by another person, the person signing the maintenance release must personally observe the work to the extent necessary to ensure that it is performed in accordance with the requirements of any applicable standards of airworthiness and, specifically, the requirements of sections 571.02 and 571.10.*

If there is complacency in signing off maintenance tasks, the whole intent of the sign-off mechanism can be lost.

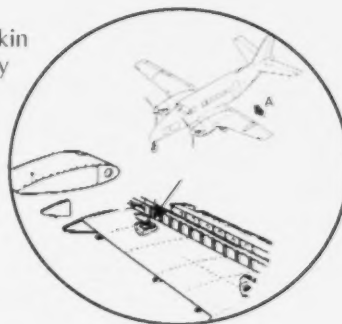
Wing Fitting Fractured

During a scheduled inspection on a Beech 99A, an AME noticed the aircraft skin forward of the wing spar and near the left wing fitting was soft and easily moved.

Further inspection revealed the leading edge pin P/N 50100002 was not engaged in the last 2 feet of the hinge on the inboard side. The hinge pin fractured where it bends to pass under the safety plate. As a result, the pin worked its way out and curled up inside the wing tip.

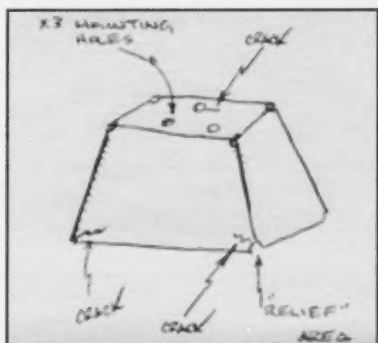
Oil Cooler Bracket Cracked

Cracking in this area is not uncommon and should be suspected when inspecting the oil cooler bracket both in service and prior to installation of a new part.

Oil cooler bracket is a welded assembly from factory.

Cracks originated from mounting holes and "relief" area.

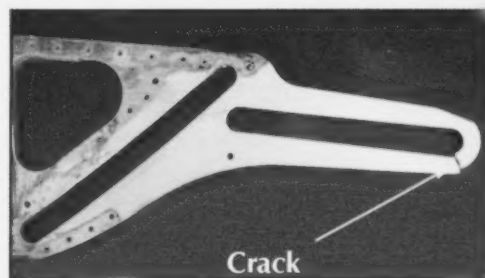
Flap Track Cracked

While performing an aircraft walk-around on a Beech A100, an AME discovered a crack in the inboard track (rear bottom) P/N 501600183 located on the right flap.

It may be difficult to detect a crack since the bottom aft portion of the track runs inside the flap. The submitter added that there are no inspection requirements to remove the flap in order to carry out an inspection of the track.

Part total time: 16,964 hours

Transport Canada reminds AMEs to remain diligent during inspection in such difficult areas and angles. You may be the one who finds the defect that is hard to find.
